WASHINGTON COUNTY RFQ 2015-03 ARKANSAS

RFQ 2015-03 CONSULTANT FOR MOLD ABATEMENT BID SPECIFICATIONS

RE: Limited mold assessment for Washington County Court House, 4 South College Ave. and Juvenile Detention Center, 885 Clydesdale, Fayetteville, AR. ATOKA, Inc., reference # 15-249.

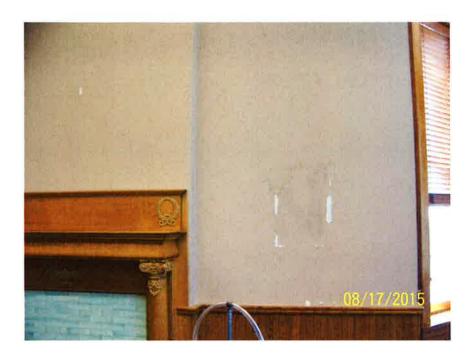
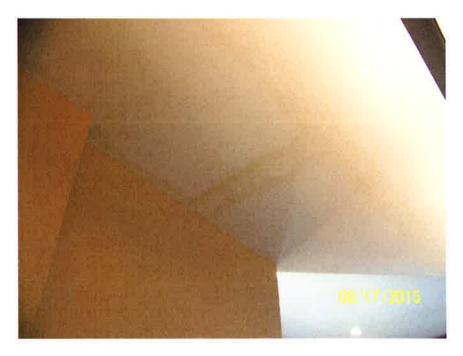
Room 206 south plaster wall on both sides and above fire place were found to be wet (above 15% moisture content)

The primary source of moisture in rooms 206 & 303A appears to be water intrusion through the south wall originating at the rain gutter level on the wall. The primary source of moisture in rooms below grade along west side of the building appears to be due to sub-surface intrusion through the foundation wall.

Room 206 wet south wall and water stained ceiling

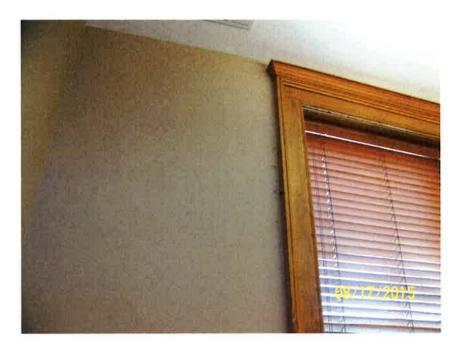
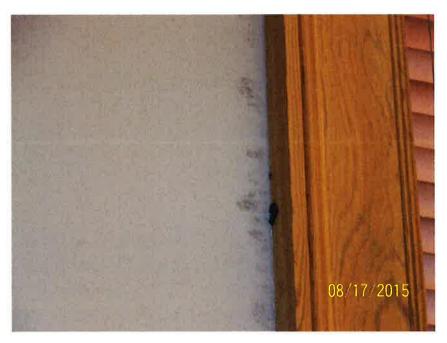
Room 303A south plaster wall on left side of window was found to be wet (above 15% moisture content)

An ambient indoor air sample(21755185) was collected in room 303A and laboratory analysis found unacceptable total indoor airborne mold spore counts of 15,000 spores/m³ comprised predominantly of *Penicillium / Aspergillus* like molds. No *Stachybotrys* sp., (Black Mold) mold was found in the air sample.

Room 303A wet south wall and visible mold along window frame.
